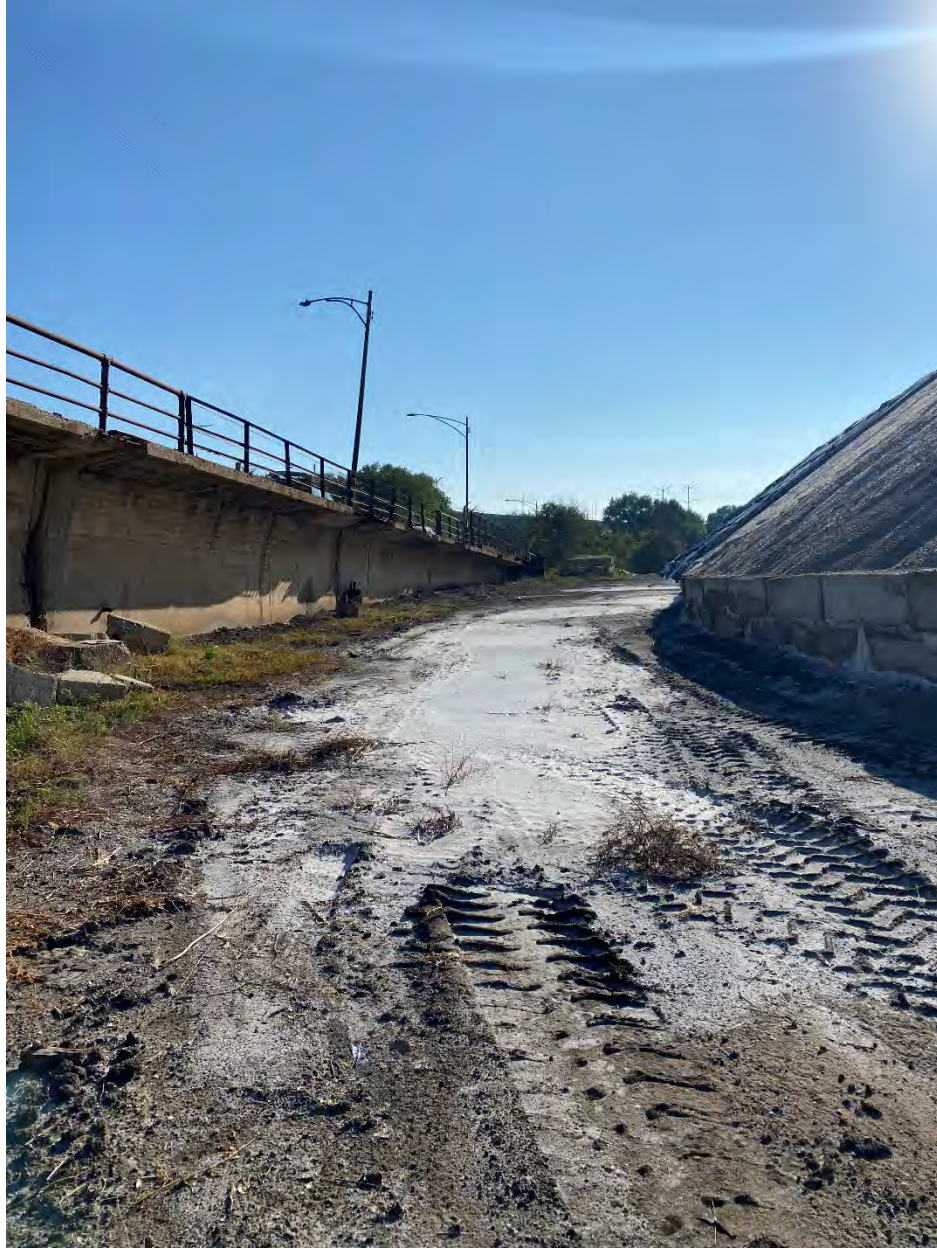
Photo 10: Salt pile retaining wall. Some salt seeps through the cracks, but Morton Salt maintains the area by cleaning. Area to the left of the retaining well receives runoff during storm event, but it does not discharge to the River.
